Kurlod-Botoshi Field Visit Notes – September and October 2014

My name is Kapil Surve and I have taken a TDSL course in CTARA department for Autumn semester of 2014. As our objective, me and my team members are studying, monitoring and scripting solutions for the water crisis in Kurlod and Botoshi habitations. The project I chose was a continuation of a previous study of water resources in the Kurlod-Botoshi habitations.

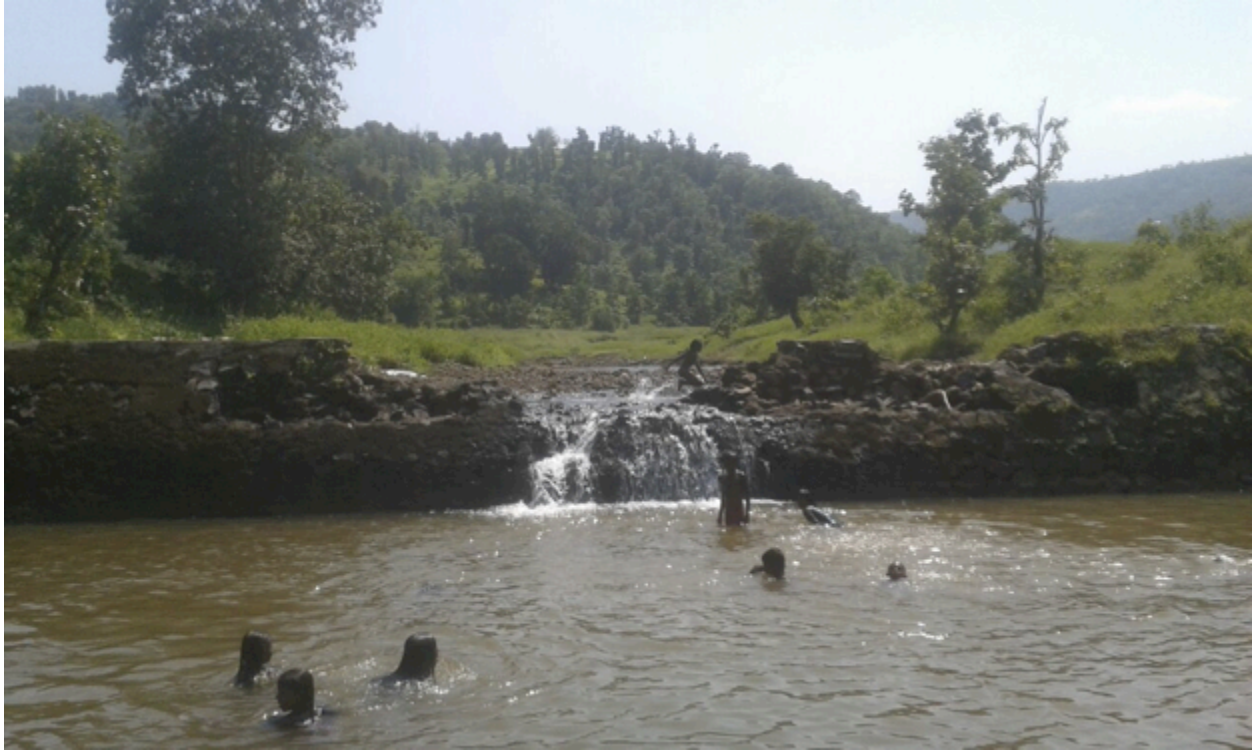
Bund 2 at Bhojpada

and took samples from it. We then visited the Botoshi's bridge/bund. We measured its storage capacity by measuring bund length, stretch of water held by bund and average depth of water. We then set out to visit the broken bund in Bhojpada. This is a relatively small bund than Botoshi but faces a *na/a* with severe force. We measured Bund's dimensions and analysed the bund's damaged part.

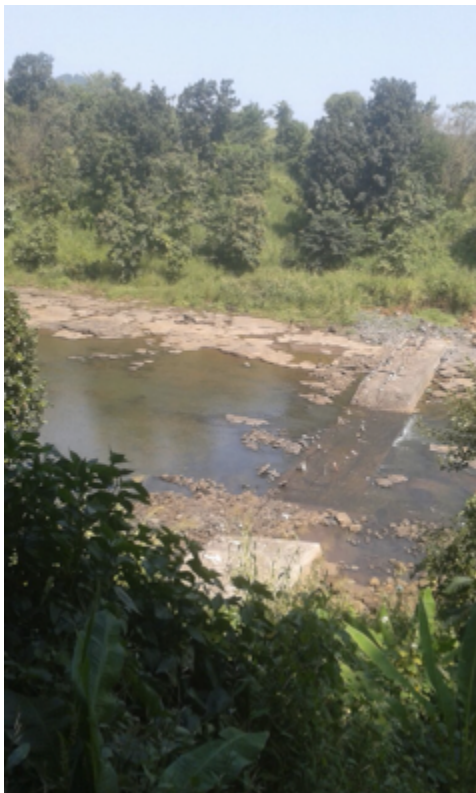
Bund at Manipada

The three of us first reached Kurlod. From here we walked to the bund site in Manipada. On observing, we found that the bund, is a massive but incomplete structure. We measured its storage capacity using our measuring tape. For doing this, we had to take the entire stretch of the water held, which was unusually long and of curving nature, signalling the importance of the bund.
