# Micro-watershed Analysis of Kurlod-Botoshi

## Status Report

MOHIT SINGHAL, MUKUL KAUSHIK (IIT ROORKEE)

CTARA | IIT BOMBAY | July 2014

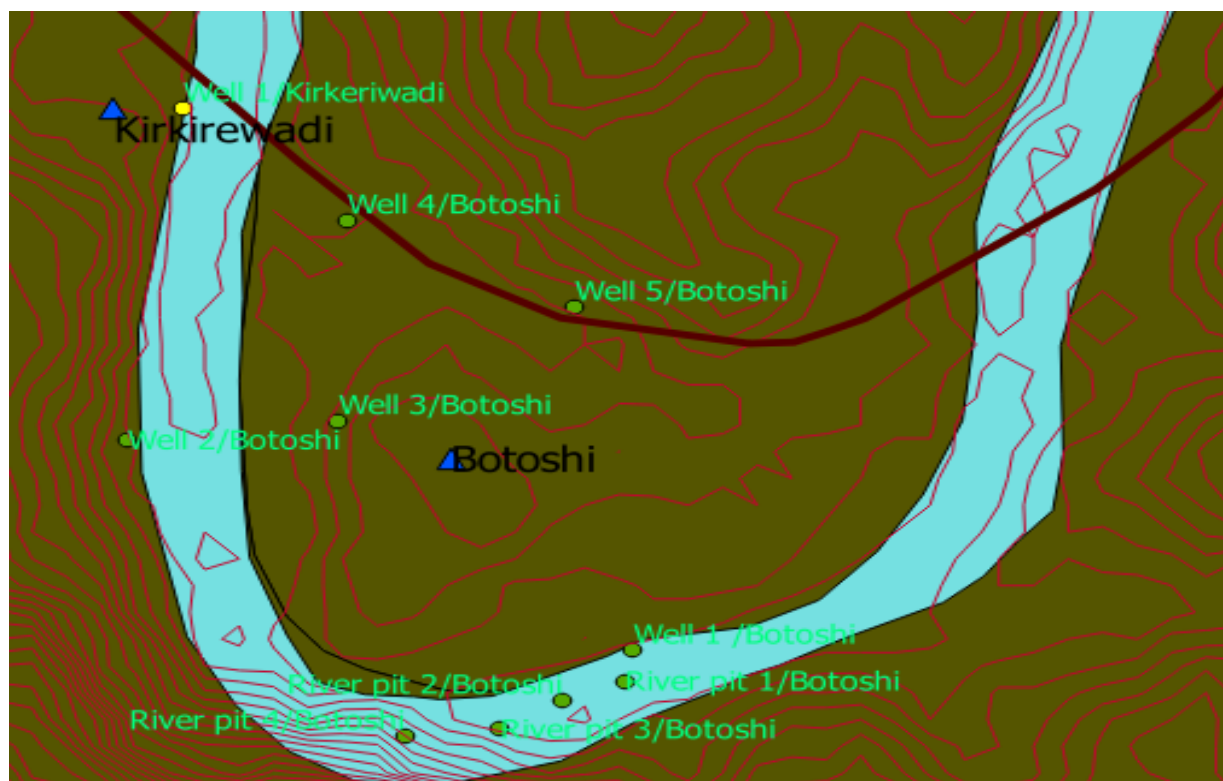
Figure 1 Location of wells in Botoshi (habitation)

The Botoshi habitation has about 68 households and a population of 400. The primary sources of water are the five wells around the habitation, most at almost 300 meters away from habitation. Out of five wells, four dry very early and one retains water up to March.

The secondary source of water is the Pinjal river which is about 300 meters from the habitation. The villagers dig pits of depth varying from one to three meters along the side of the river and collect water from the pit. There's a bund as well along the stream but it's broken. Besides poor water availability, a major issue at the Botoshi habitation is accessibility; the habitation is almost one kilometer from the closest road and a river needs to be crossed to reach it. Healthcare is also severe issue – the nearest health center is in Khodala which is 20 km away.

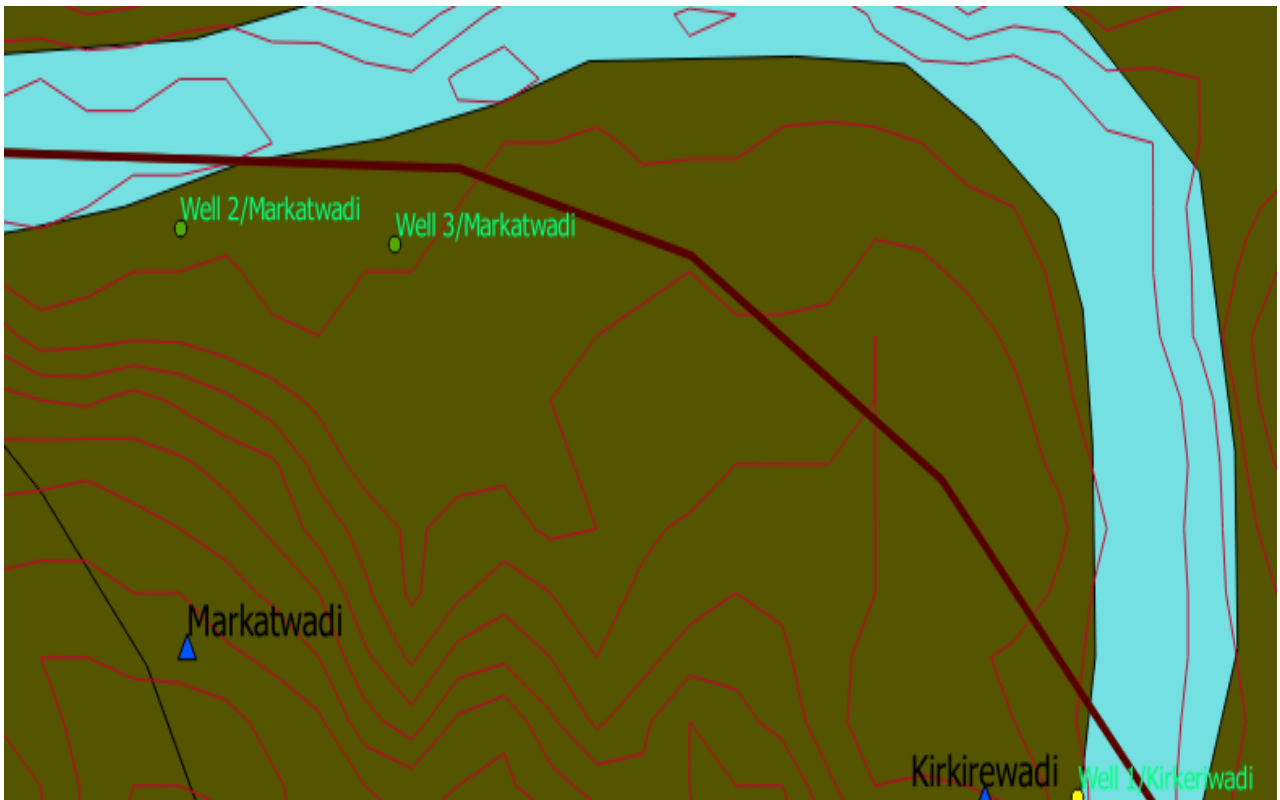
Figure 2 Location of wells in Markatwadi

Markatwadi is another habitation of Botoshi village. There are 25 households here and the population is around 150. The primary source of water here is well water. There are three wells here that retain water up to the month of December only. After that people go use the river as secondary water source. Primary and secondary sources of water are 300 and 350 meters from the habitation respectively. As long as water remains in the wells i.e. up to December, people use it for drinking purpose and the river for other uses. After that, they are totally dependent on the river. There is a primary school in the Markatwadi habitation, but healthcare and connectivity are major problems here again. This habitation gets totally cut off during monsoons.

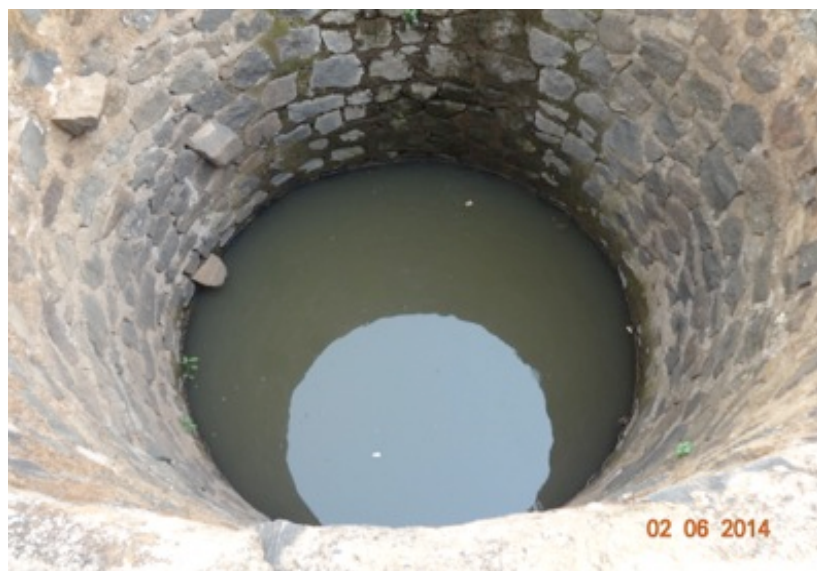
Figure 3 Well in Kirkirewadi (June 2014)

You can reach Kirkirewadi habitation through Botoshi habitation after crossing the Pinjal river by foot. There are only eight households here and the population is merely 40. The primary source of water is the one well here, which retains water for the whole year but in April-May, the water in this well isn't drinkable. During this time people go for river water as a secondary water source. Primary and secondary sources of water are around 100 and 150 meters from the habitation respectively. There is no school in the habitation - children have to Markatwadi for primary education after crossing another river stream in between. Again, the major problems here are healthcare and connectivity. This region gets totally cut off during monsoons. There hasn't been any bund constructed in this region yet. According to people over there government hasn't implemented any scheme there till now.

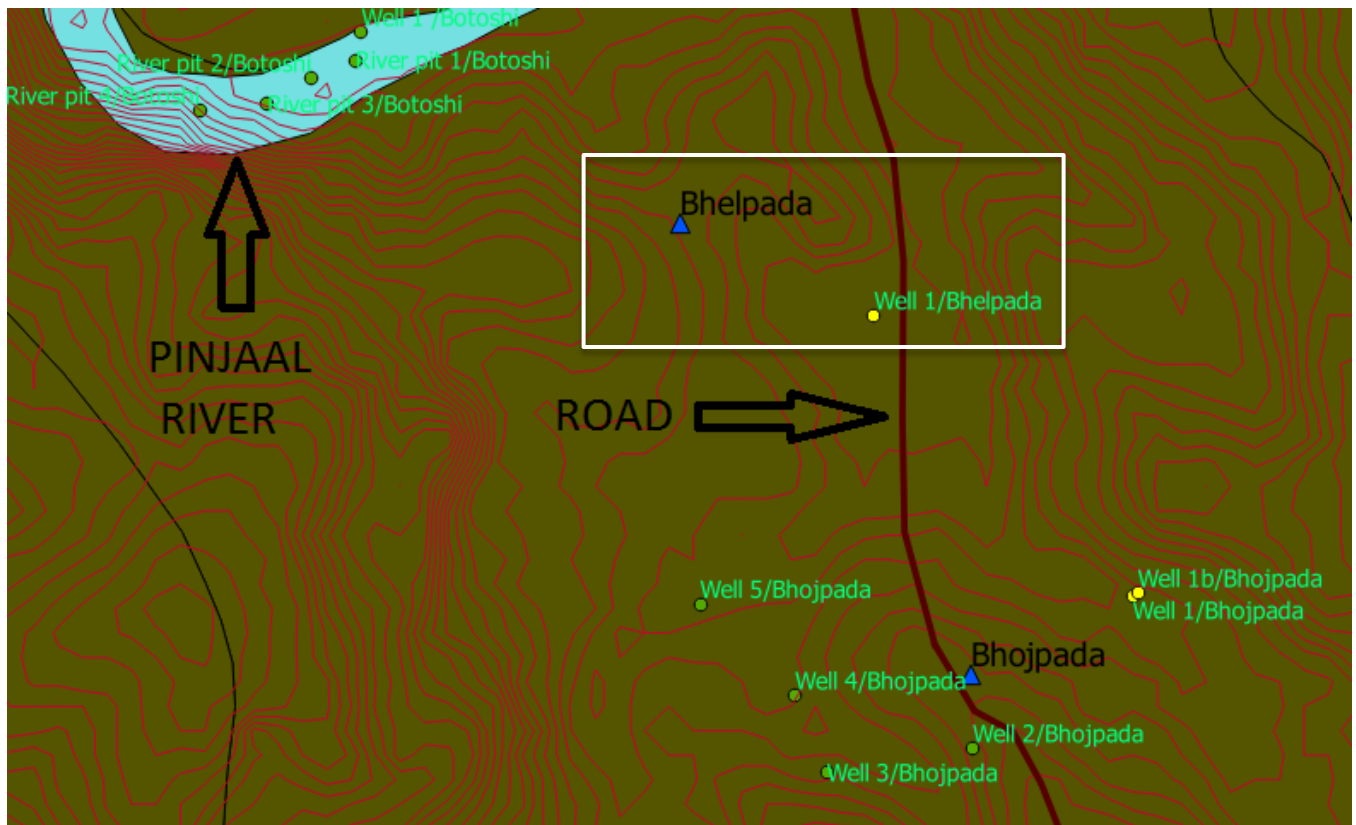
Figure 4 Location of well in Bhelpada

Bhelpada has 50 houses and a population of 450. There is one well, which is at a distance of almost 200 meters and which meets the needs of villagers up to the month of June. After June, it does not remain suitable for drinking purposes. The river is used for other daily uses and after June villagers become entirely dependent on the river which is almost 500 meters from the habitation. Again, the healthcare issue is severe here: the nearest health center is in Khodala which is at a distance of 20 kilometers. The electricity is in about 35% of homes. As a pakka road passes through this habitation, there is no issue of connectivity here. There is primary school in the habitation.

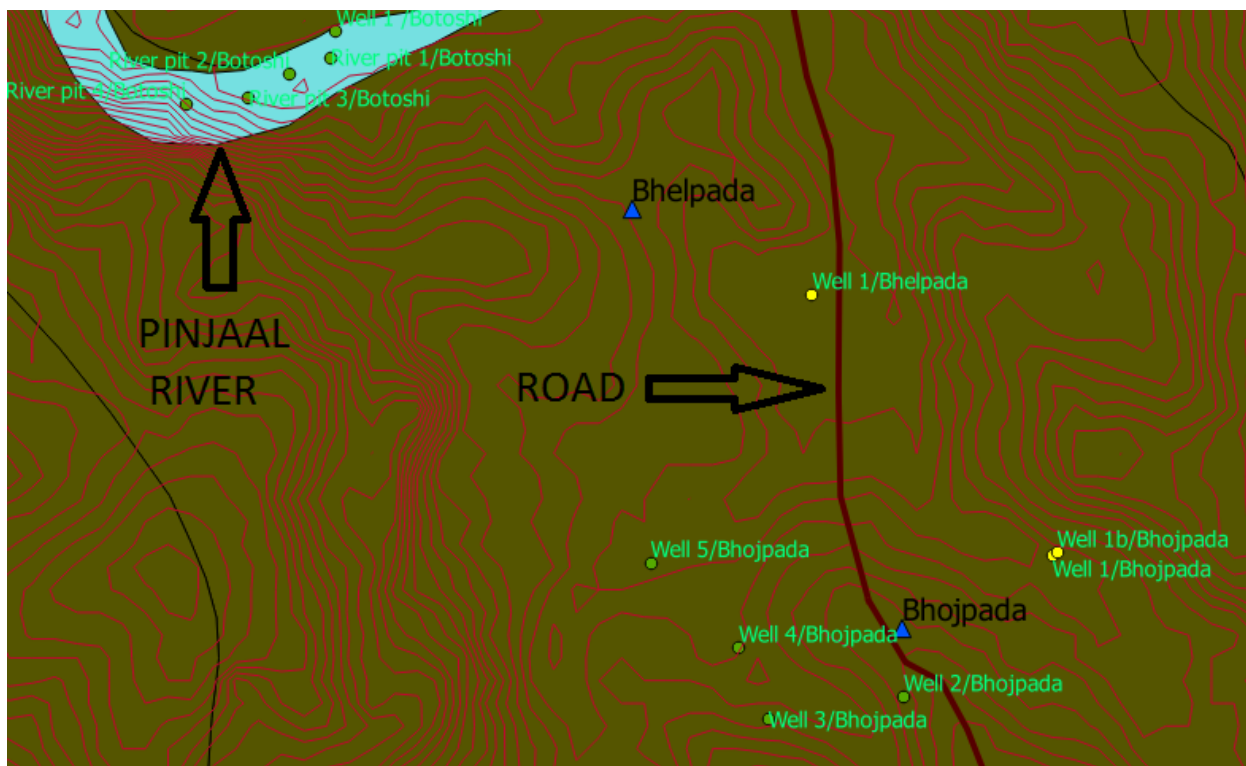
Figure 5 Location of wells in Bhojpada

Bhojpada is connected to the road network by a pakka road; it lies on two sides of that road. There are 65 houses in the habitation and the population is 340. There are five wells in Bhojpada. In two of them, water remains for the whole year and in the rest, up to October only. In those two wells, people use the water of only one well as it is transparent and seems of better quality. This well could possibly be used for supplying water to Botoshi by some means.

In Bhojpada, there are two bunds, one of them is highly silted and possibly leaks. The second bund is able to retain water for few months only. There is a primary school in the habitation but access to health care is a problem.

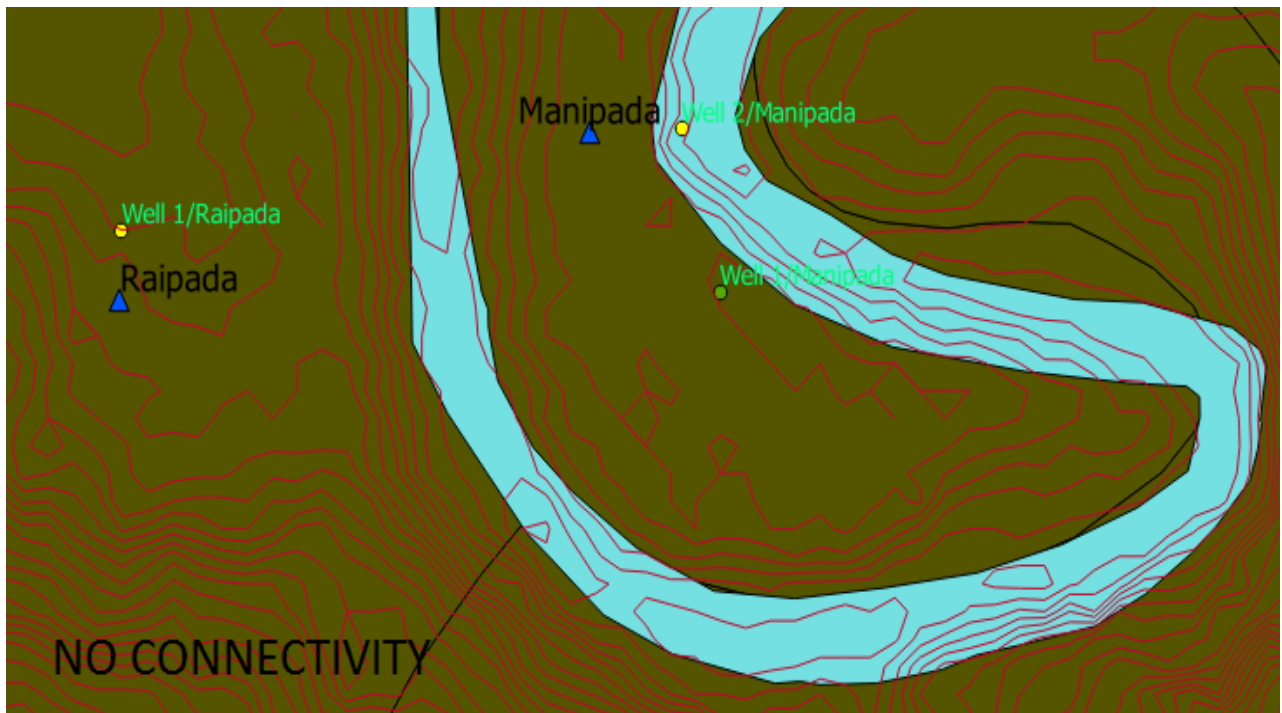
Figure 7 Location of wells in Manipada and Raipada

Manipada has only 17 households and a population of 60. There are two wells here: one dries in October and other one retains water for whole year. The habitation has a partially constructed bund with a length of 70 meters which can be a major source of water for nearby people.

There are 22 households in this habitation and the population is around 80. There is one well in the habitation which villagers say lasts through the year but whose water is unfit for drinking. Villagers still use the water for drinking, however. There was an additional well that had been washed away by the river flow last year. Villagers in Raipada say that that well had better quality of water and had water available for the whole year. In the same stream, there is a bund in which the water is available up to February. There is electricity and a primary school here, and for further education children go to the ashram shala in Adoshi.

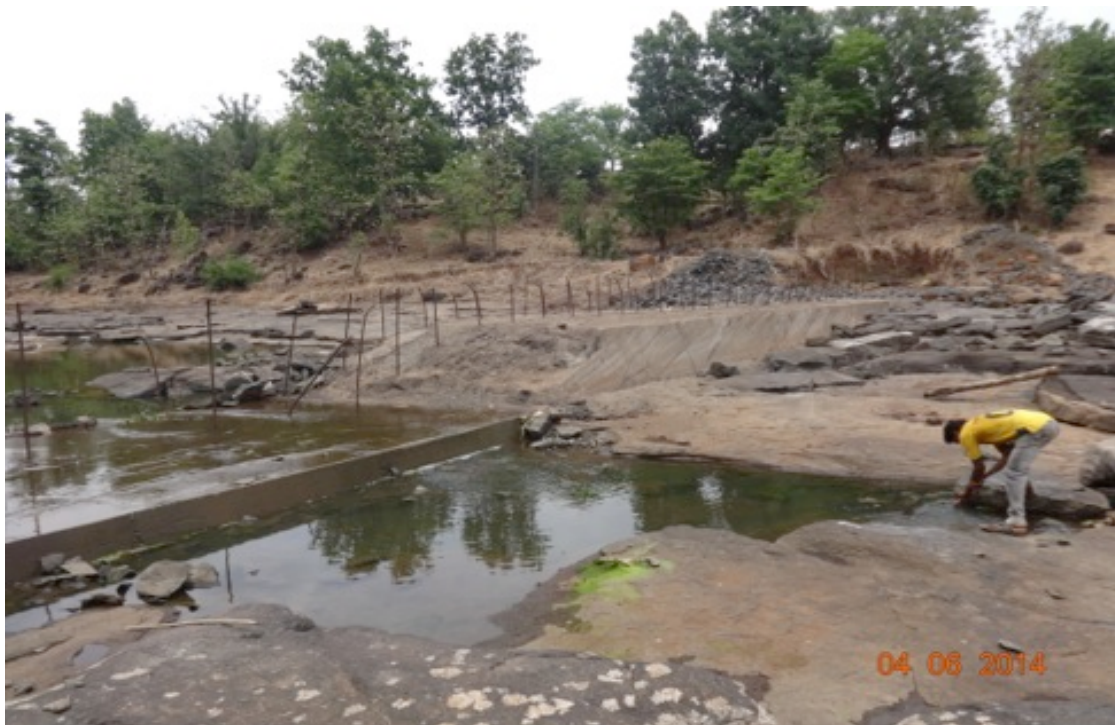
Figure 8 Incomplete bund at Manipada (Kurlod)

Manipada has an existing bund, which is completely broken as shown in the figure below. If it is repaired, it would help recharge well-2 and also provide water for livelihood purposes.

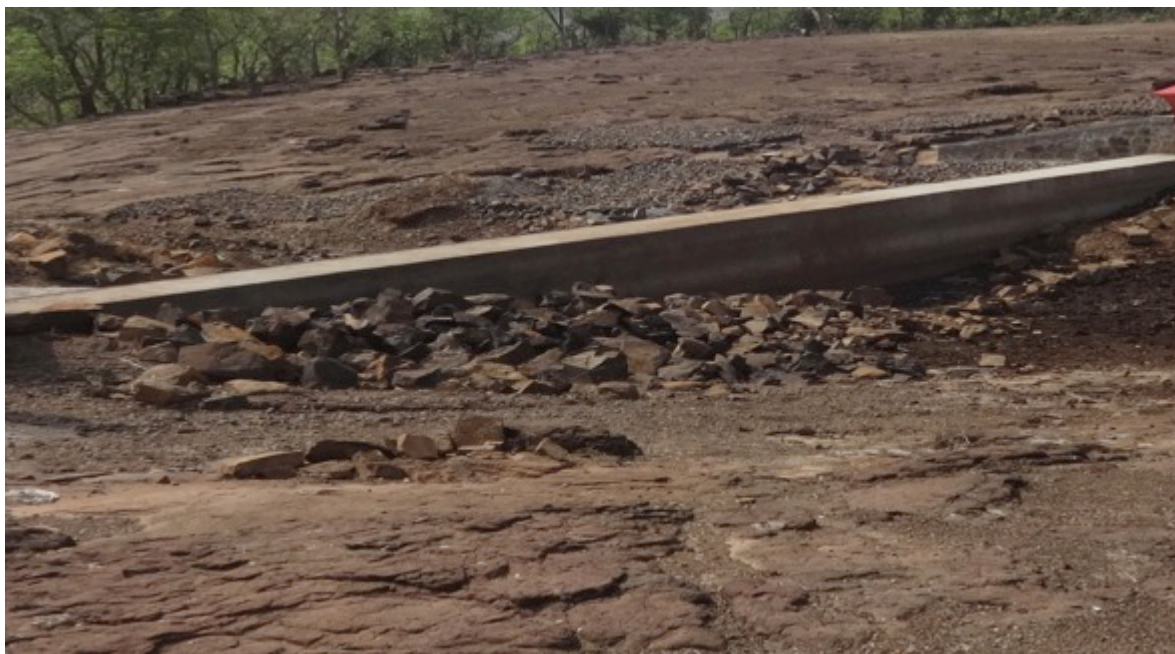
Figure 11 Siltation in bund in Kurlod habitation

Figures below show the bund (“bund1”) that is highly silted and leaking. It lies on a stream, just downstream of a well (“well4”). If this bund would function properly, well4 would get better recharged. This well is used by both by Kurlod and Pethechapada and right now retains water up to the month of May, but the villagers surveyed believe it cannot sustainably supply to both habitations due to the low quantity of water available each day. Repairing the bund could solve both drinking and livelihood water issues in Kurlod and Pethechayapada.

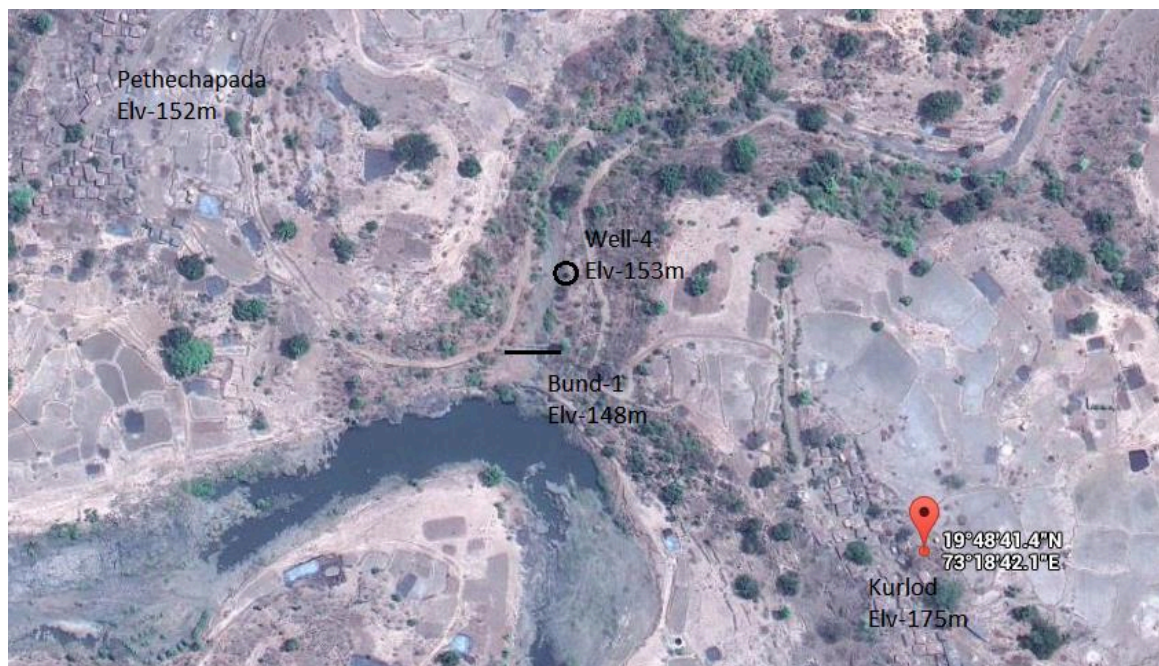
Figure 5 Location of bund-1 in Kurlod habitation

Figure 6 GIS image showing location of bund-1 in Kurlod

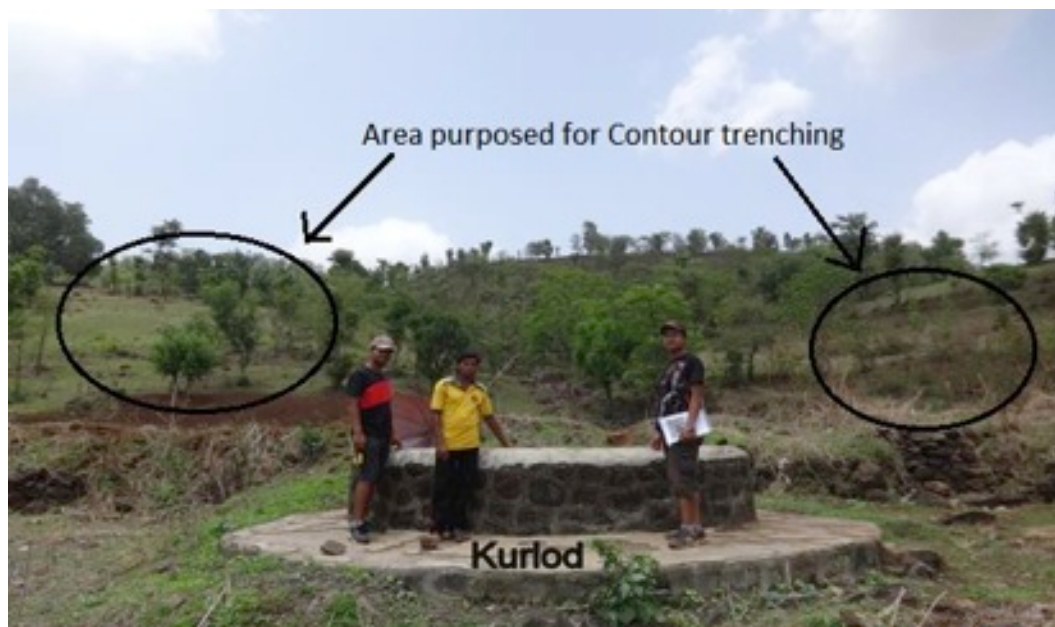
Figure 17 Possible location for contour trenching in Kurlod

In Kurlod, to recharge 'well2' and 'well3' as shown in figures below, contour trenching can be done on the hills just beside them. It will help in recharging groundwater and hence recharge these wells.

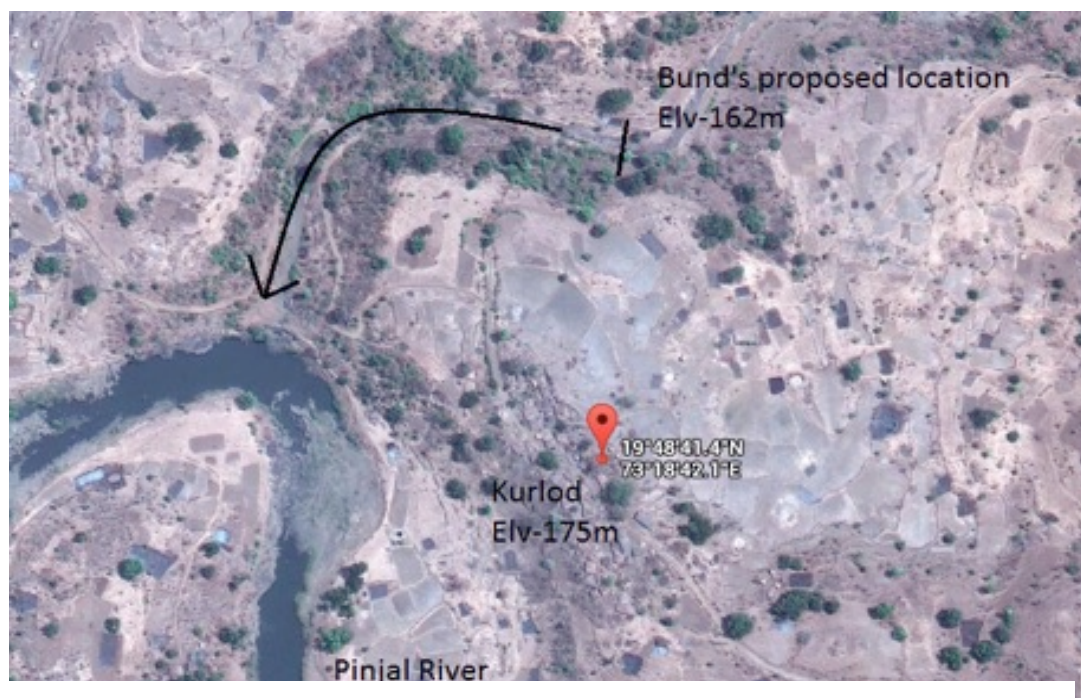
Figure 18 Possible location of a new bund in Kurlod

In Kurlod, near 'well-2', there's a stream having very high natural embankments with around 13 meters depth. This site may be fit for a new bund. The figure below shows the location where the bund could be constructed. The increased water storage from this bund would provide water for livelihood by allowing farmer to irrigate winter crops as well.

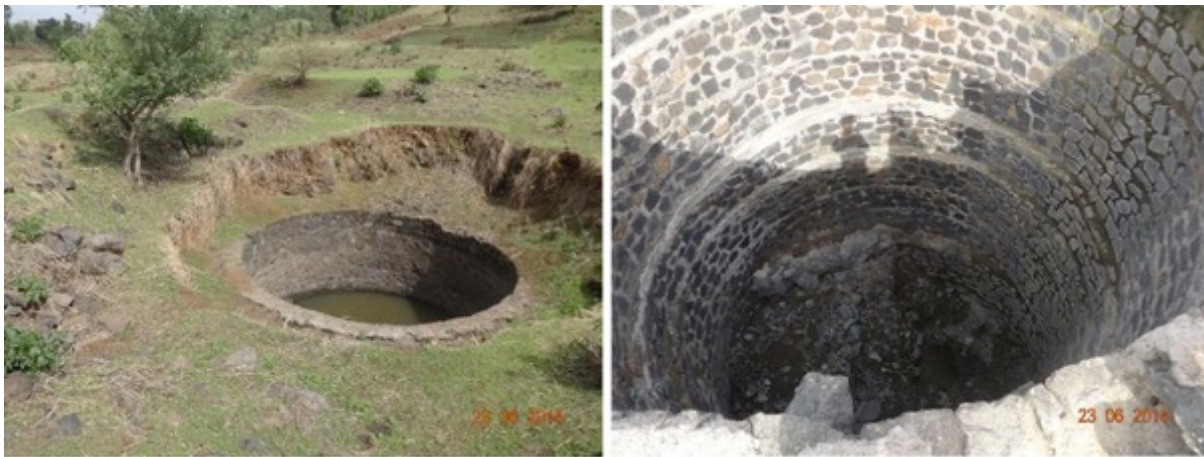
In Markatwadi, one well ('well3') needs to be cleaned and dug more. Currently its depth is merely a meter or two. There is another well ('well2') near it, which is incompletely constructed.

Figure 19 Wells for repairing in Markatwadi

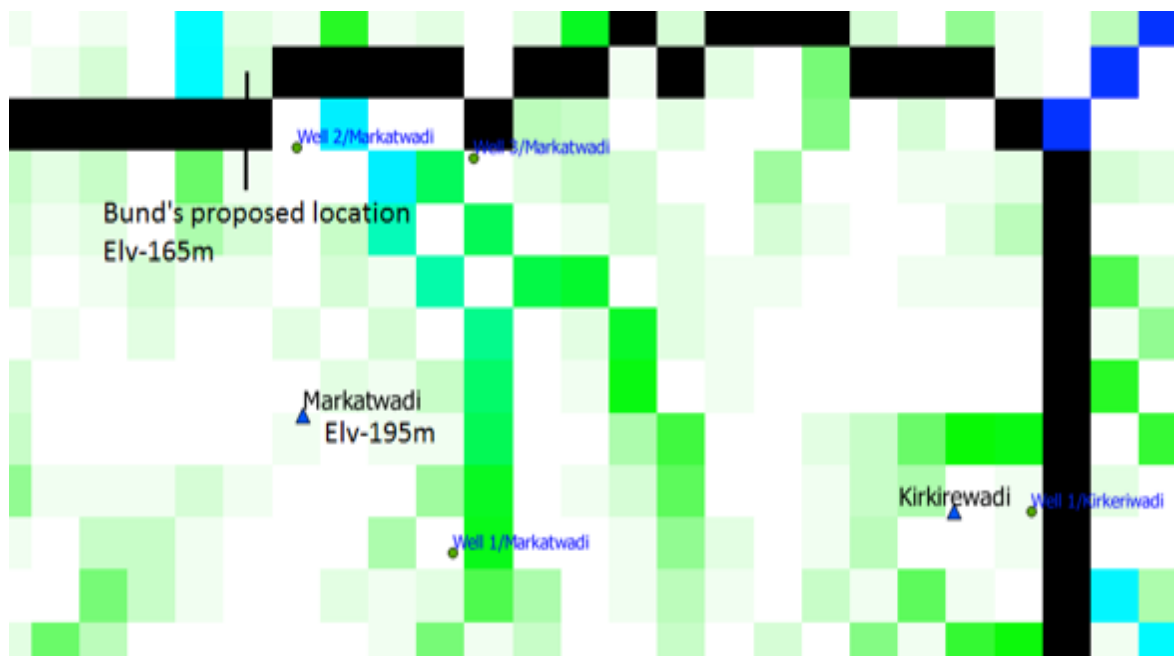
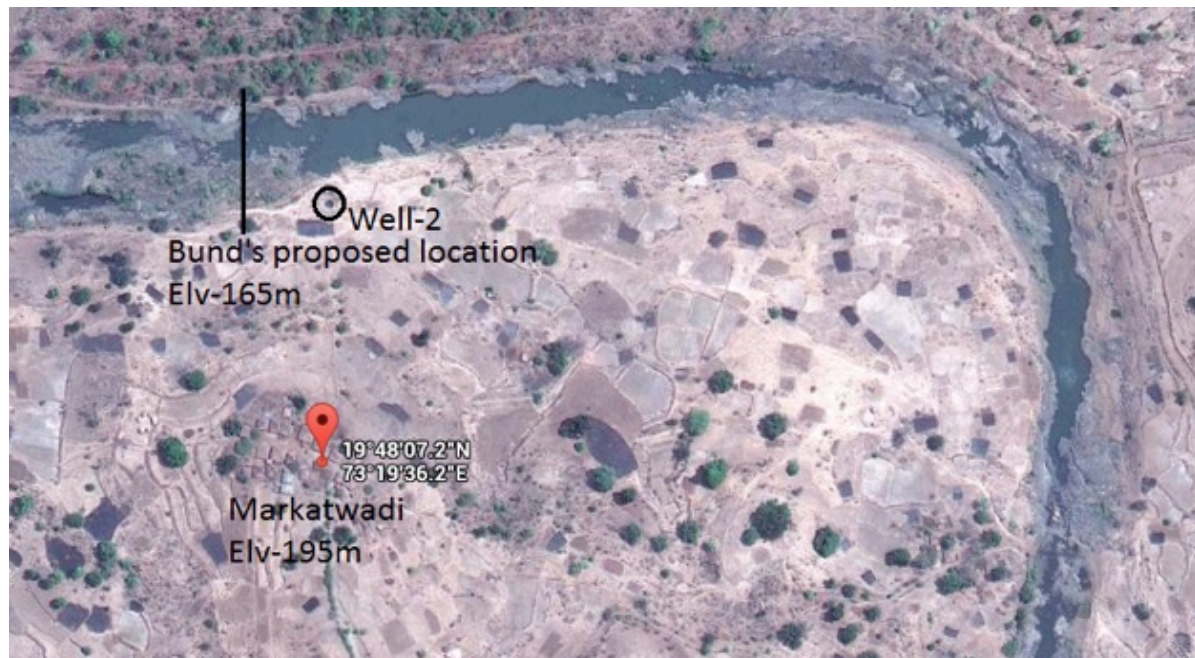
Figure 7 GIS image of bund location in Markatwadi

Figure 21 Location of a possible new bund in Markatwadi

There is a stream passing beside these wells; if a bund is constructed on this stream, this bund may recharge both wells.

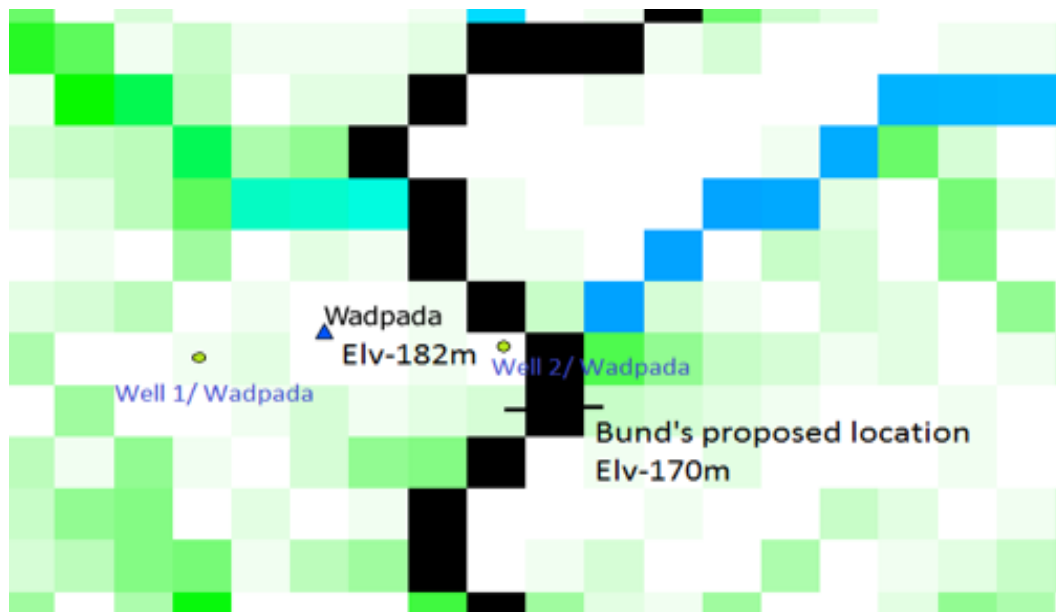
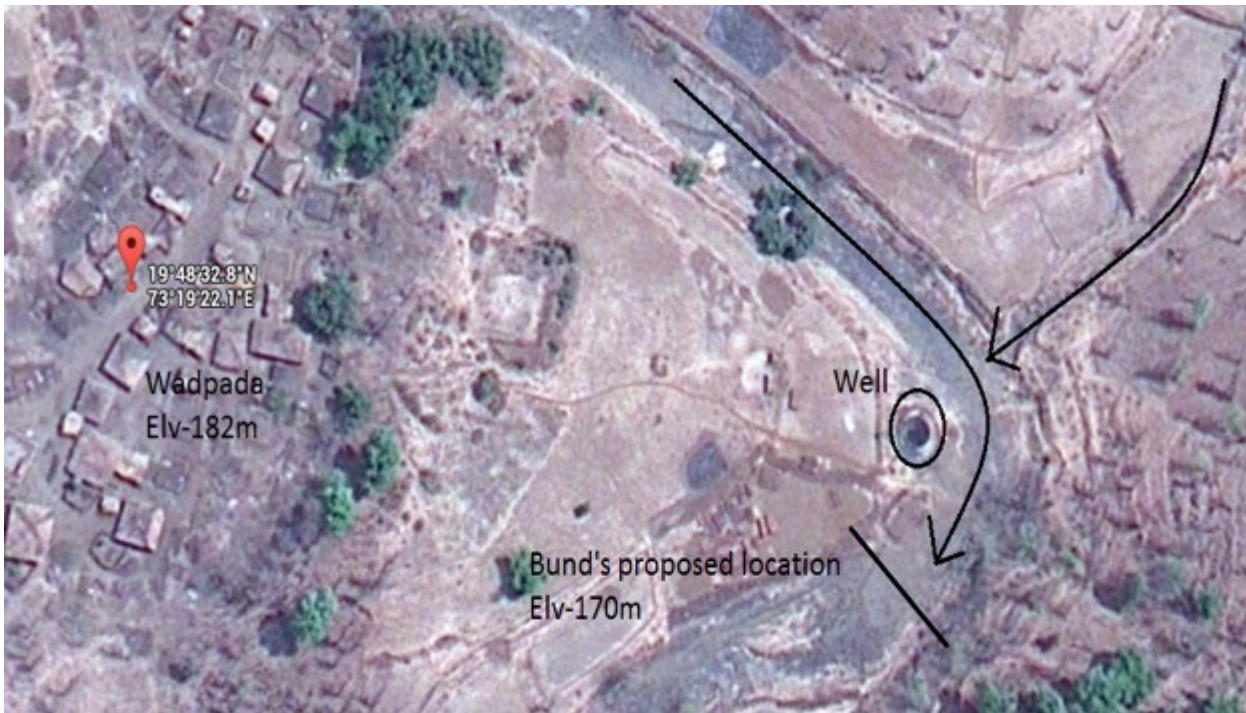
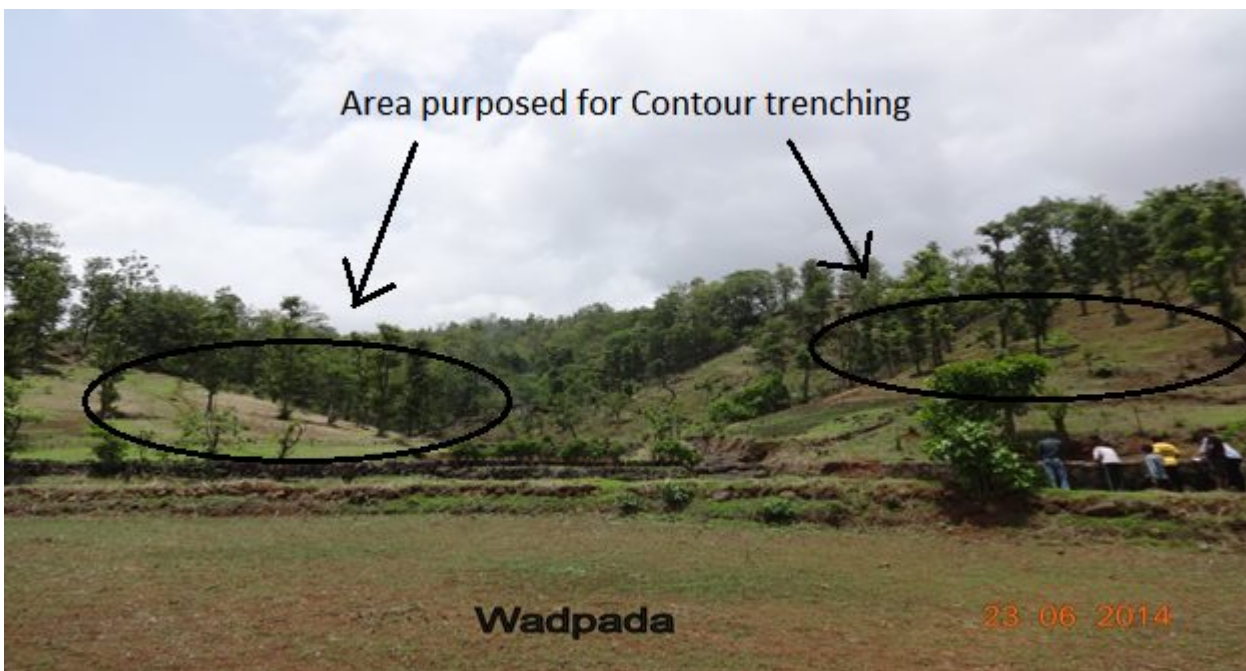
Figure 22 GIS image showing location of possible bund in Wadpada

Figure 8 Location of possible bund in Wadpada

Figure 24 Possible location for contour trenching in Wadpada

In Wadpada, near 'well-2', there are two streams coming together and forming one single stream as shown in the figure. On the hills just above well, contour trenching can be done which will recharge this well. Also, if a bund is constructed here, it could create a reservoir along the stream, which would recharge the well for drinking purposes and store water for livelihood purposes. So, a bund here may serve to supply water for both drinking and livelihood purposes.

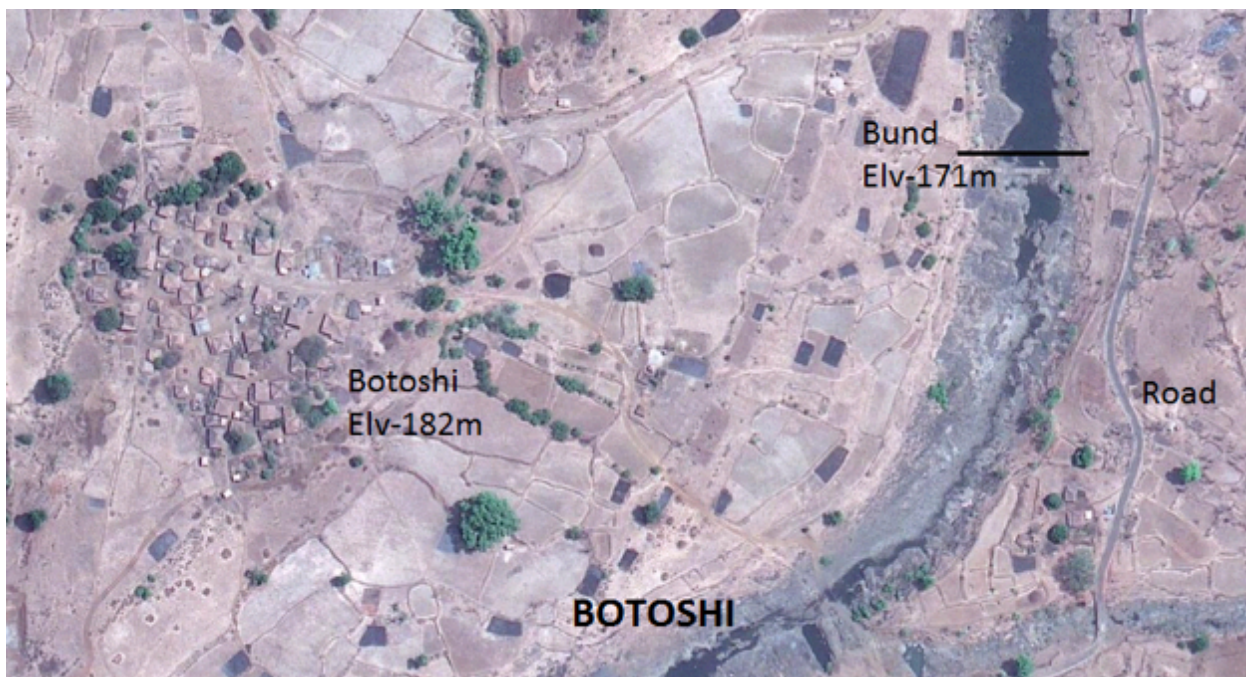
The bund that connects the pakka road to the habitation is broken, so in the monsoon season the habitation gets cut off, and the storage of water is limited. If the bund functions properly, it may serve the need for both connectivity and livelihood water.

Figure 25 Google Earth image showing location of broken bund in Botoshi

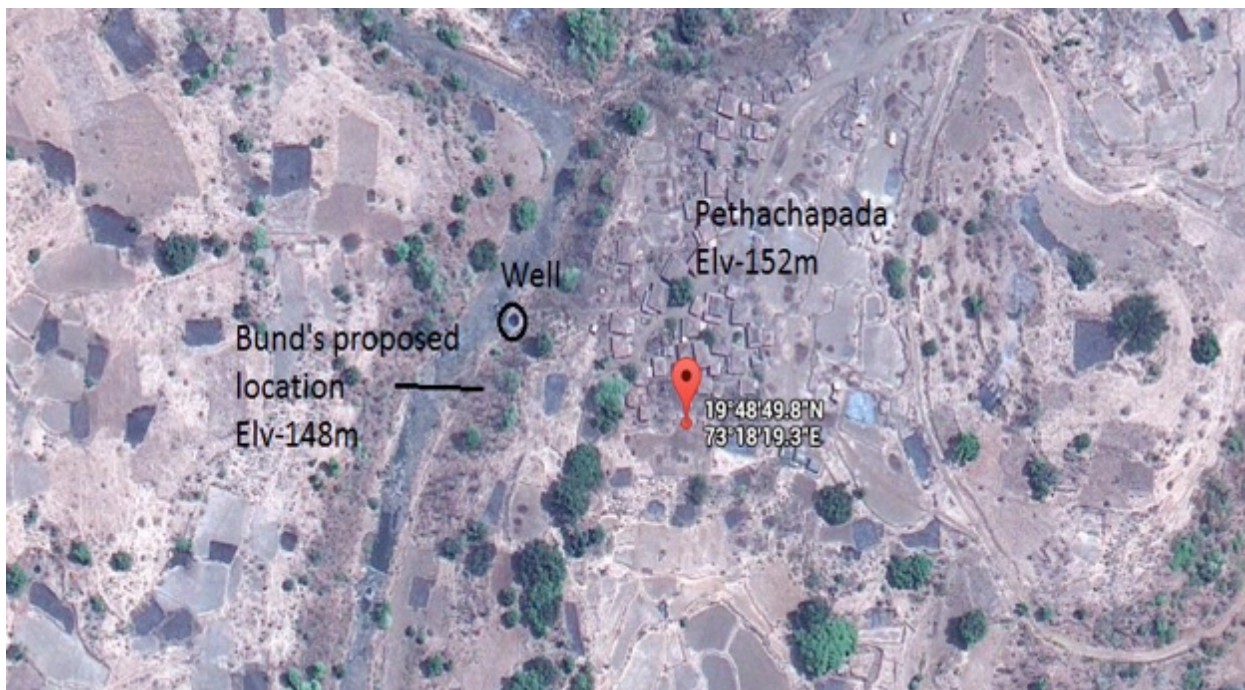
Figure 26 Possible location of a new bund in Pethechyapada

In Pethechyapada, a bund can be constructed at the location shown in the figure. It can be seen that the embankments of the bund are well defined. A bund constructed here would increase drinking water availability by helping recharging 'well-1' and also allow water to be stored for livelihood purposes.

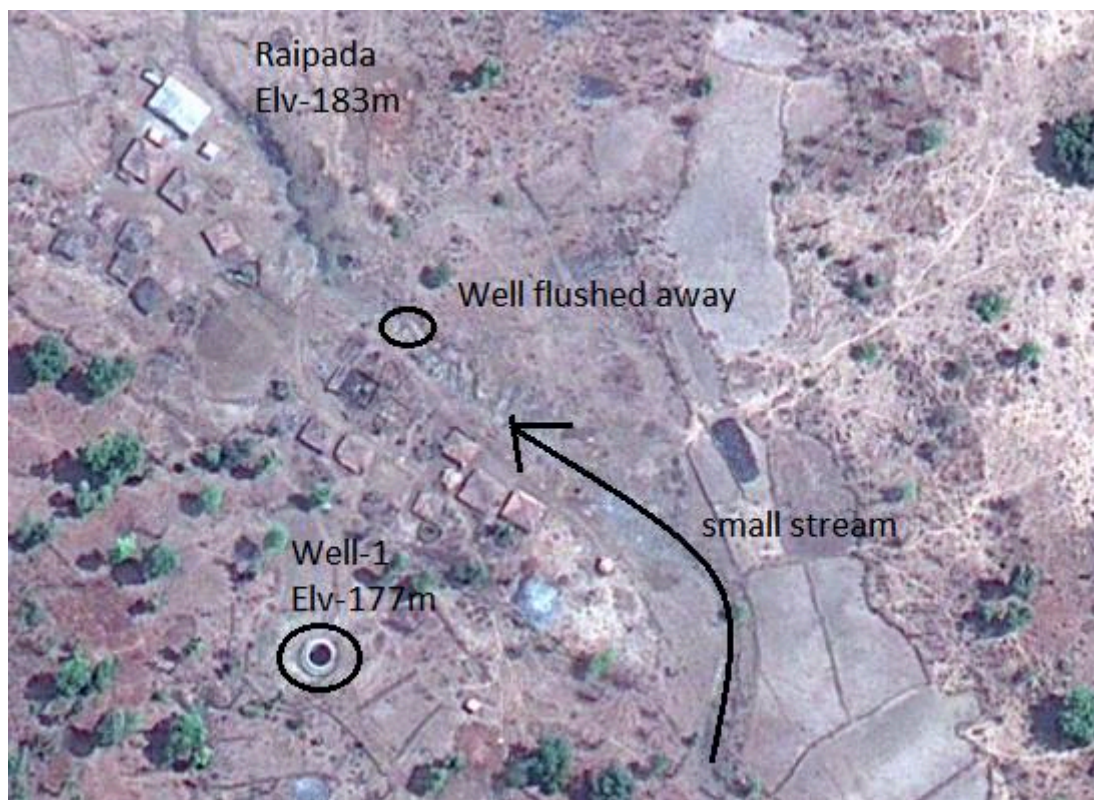
Figure 9 Well for repairing in Raipada

To ensure that Raipada has a safe drinking water source, the well that was flushed away could be repaired.

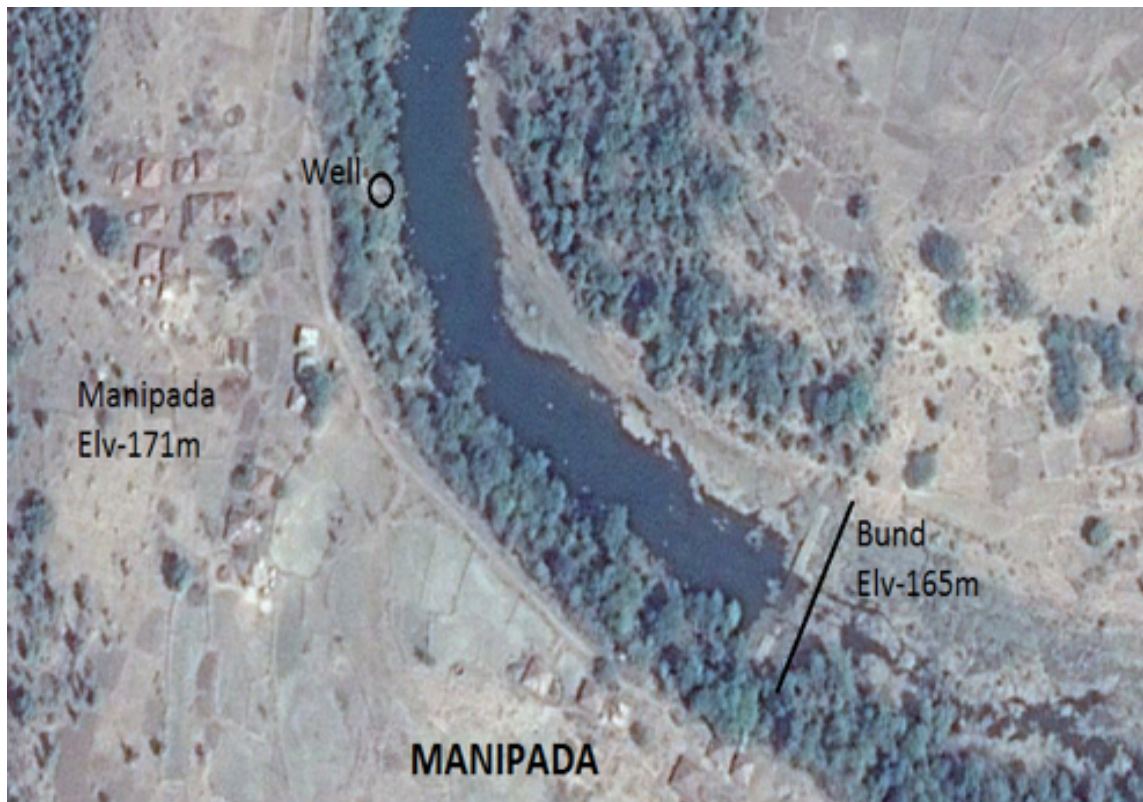
Figure 28 Location of well to be repaired in Manipada

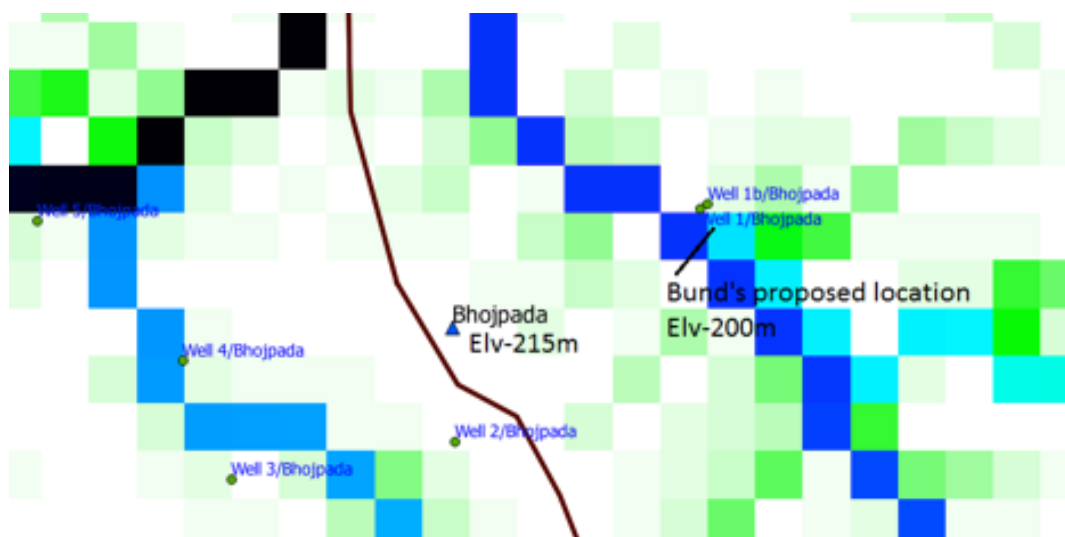
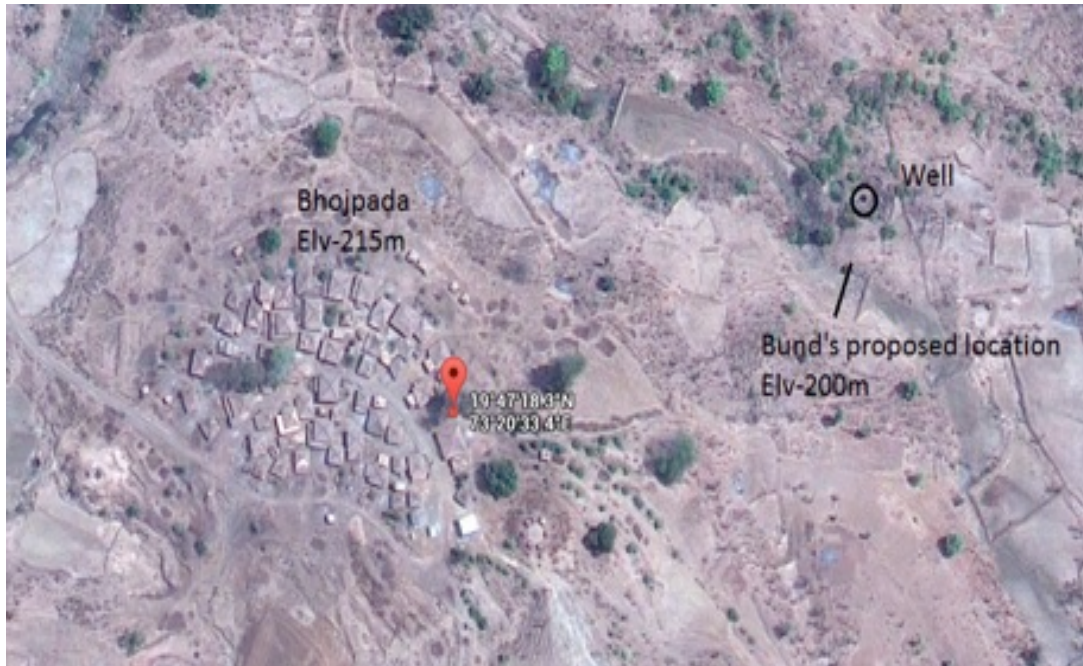
Figure 10 GIS image showing possible location of a new bund

Figure 30 Possible location of new bund in Bhojpada

In Bhojpada, the way to well-1 gets cut off by a stream during the monsoon season. A bund constructed on the stream would help recharge the well and provide a means to reach it. A possible location for the bund can be seen in figures below:

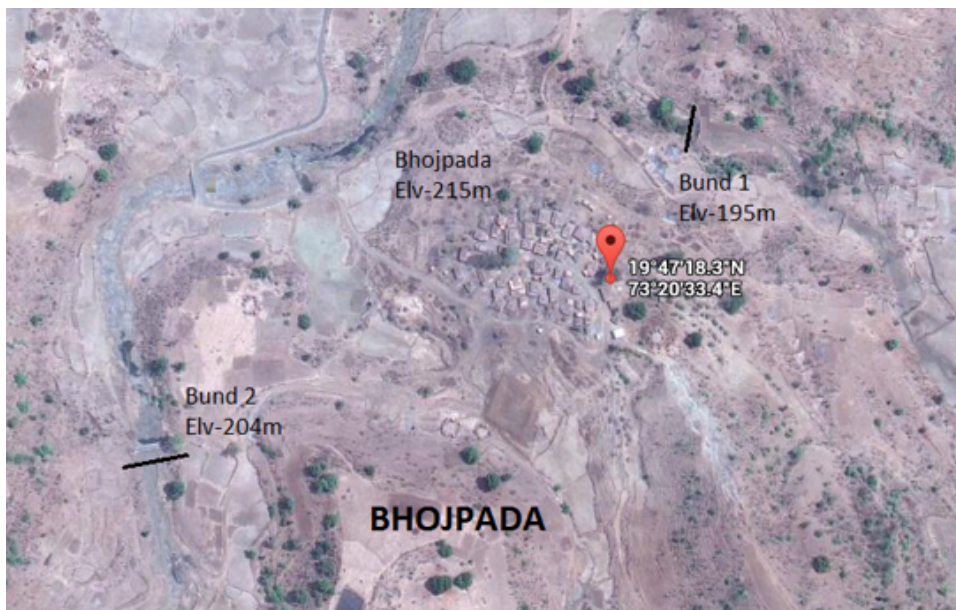
Bund-2 in Bhojpada, at an elevation of 204 m, appeared to have leaks and siltation. If it is repaired and desilted, the water stored in the bund could be used for livelihood purposes

Figure 11 Location of bund for repair in Bhojpada
